PHASE I ENVIRONMENTAL SITE ASSESSMENT

LYNDEN FARMS PROPERTY
6135 N. BASIN AVENUE
PORTLAND, OREGON

8-61M-09913-0

August 1998

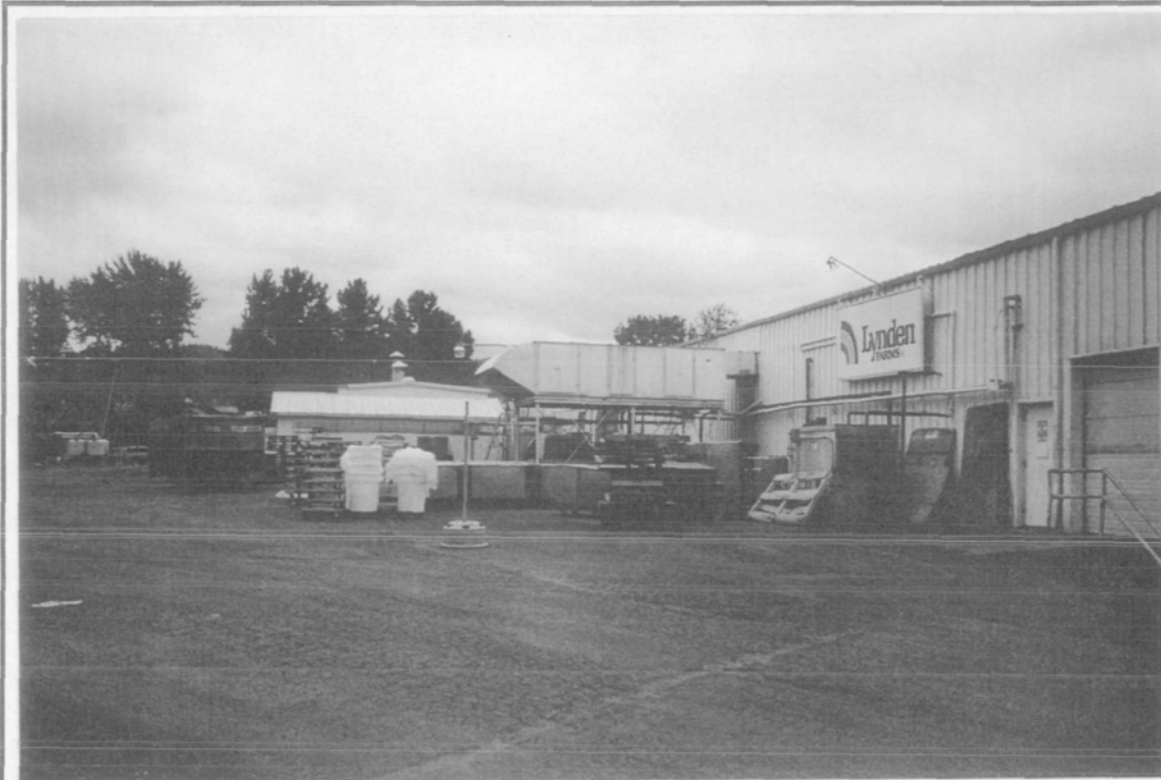
The site was considered generally clean and free from the widespread dumping of litter and debris. One garbage dumpster was observed along the southern side of the main plant building, in the general area of the Chiller room (Photo 1).

PHOTO 1: View of the western portion of the subject site showing location of garbage dumpster (left) and main chicken processing plant building on the right.

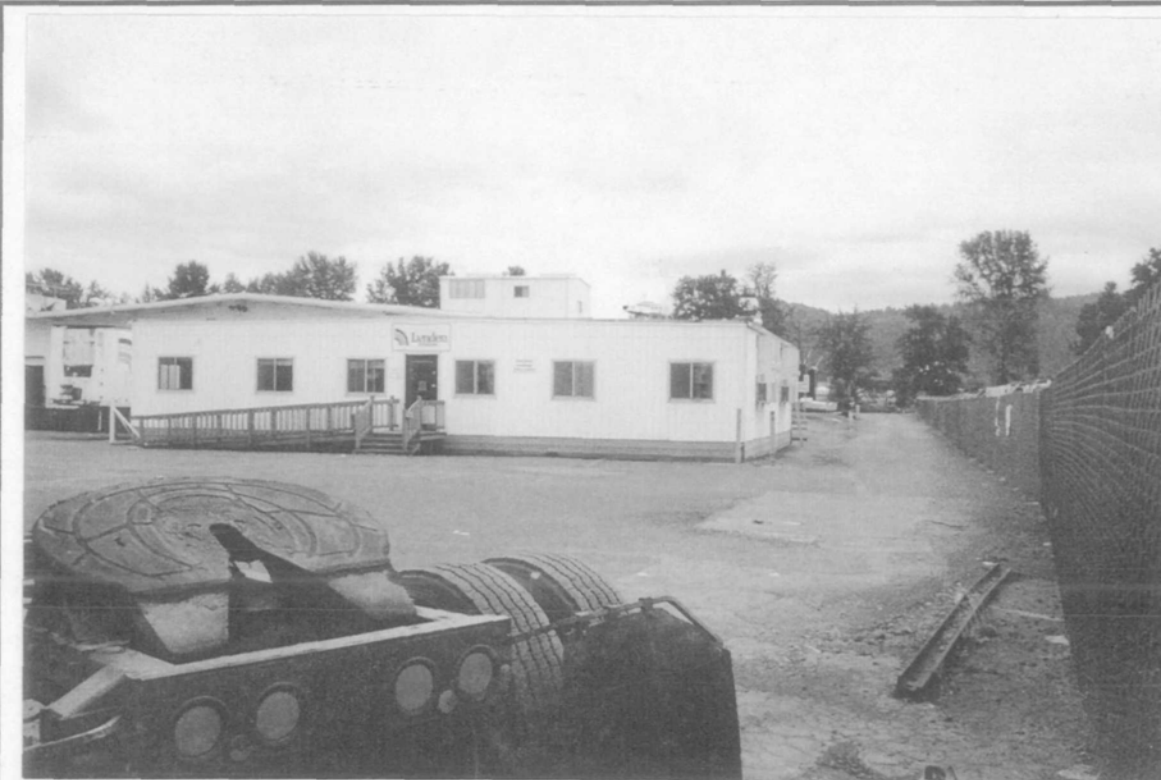
PHOTO 2: Westerly view of the northern portion of the subject site showing office trailer and approximate location of former diesel and gasoline USTs.

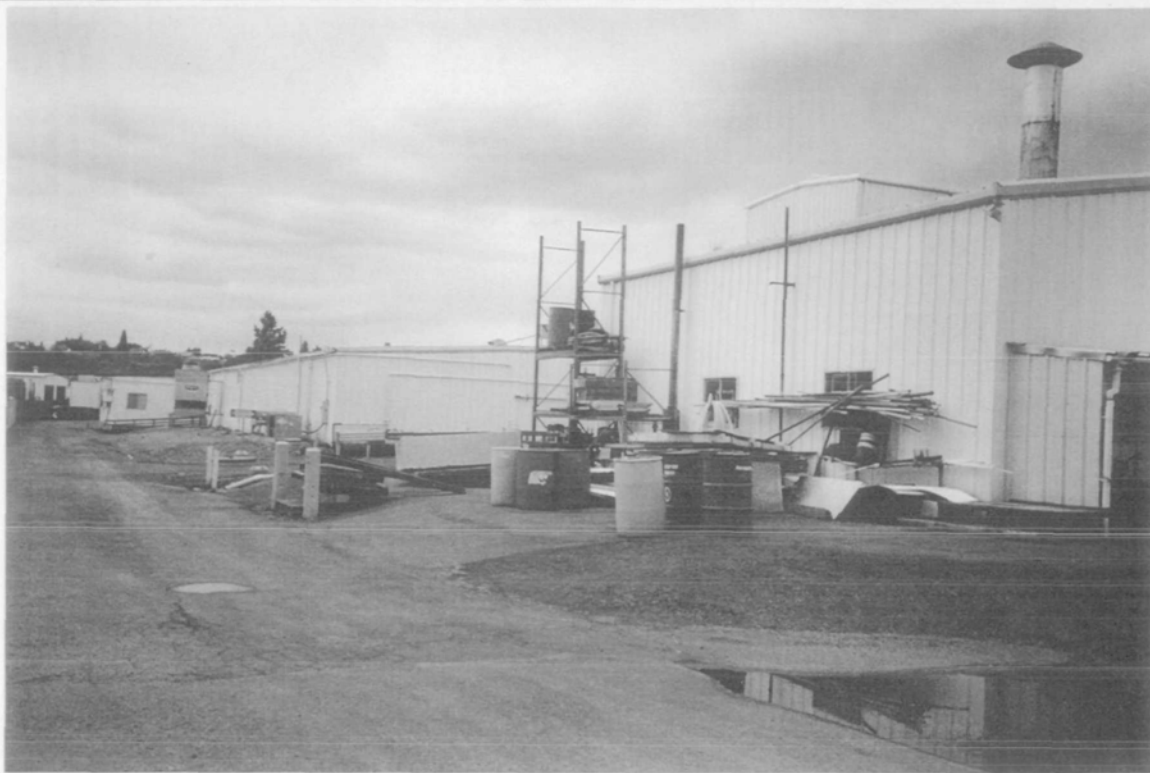
One heavily oil-stained area was observed outside the boiler room door on the west side of the building (Photo 3). Numerous 55-gallon drums of machinery oils and industrial oils and other lubricants were formerly stored in this location, reportedly since the building was constructed between 1977 and 1982. The area of the oil staining appeared to be contained by a concrete berm on the three sides and bordered by the building on the fourth side. No major staining of asphalt was observed outside of this drum storage area. A storage rack used for the storage

PHOTO 3: Easterly view of the subject site showing location of former diesel UST location and boiler room with covered chemical storage area (far right).

Heavy oil staining also was observed in the former chemical barrel storage area to the west of the boiler room. AEE recommends that soil samples are collected in this area to evaluate the extent of soil contamination.

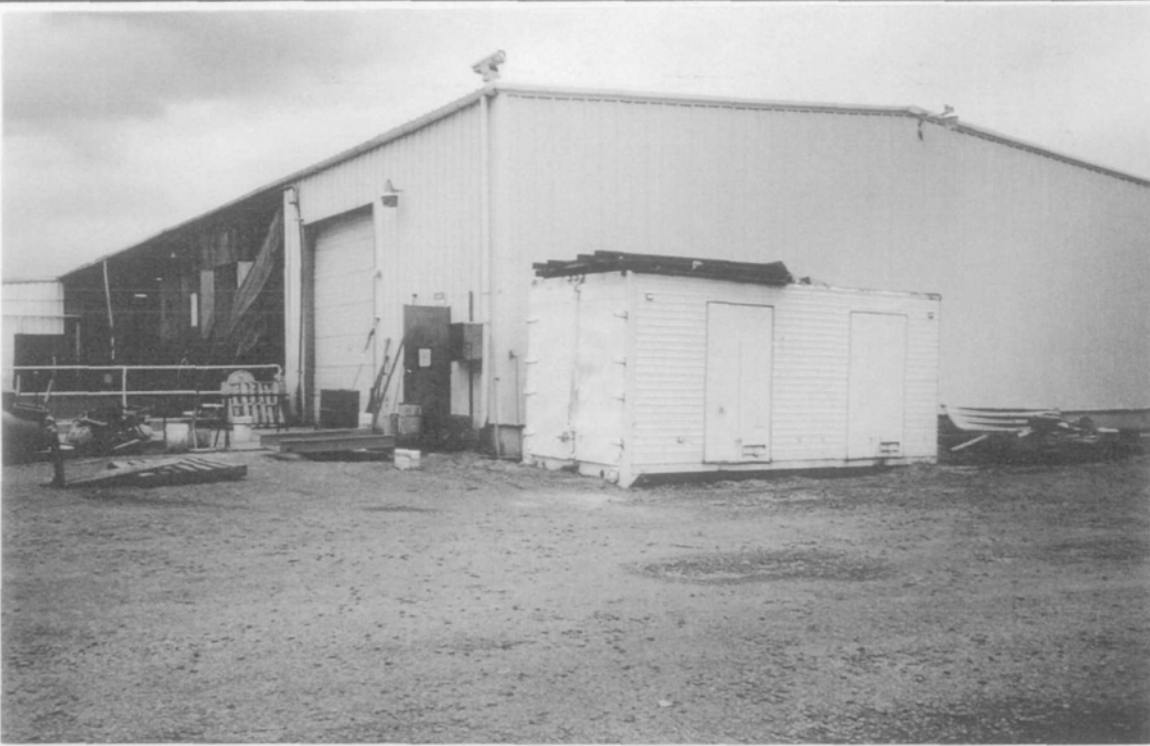
Visible surficial staining was observed outside of the vehicle maintenance shop in the area of the waste oil UST and appears to have originated from some spillage of a 5-gallon drum located adjacent to the observed stain near the entrance door to the maintenance shop (Photo 4). According to Mr. Holtz, the drum contains a solvent used for cleaning up oil. Two additional drums of unknown contents (55 and five gallons) also are located in this area (Photo 4). A white 10- by 20-foot storage container was observed directly southwest of the truck

A drum of solvent was identified near the entrance door to the truck maintenance building. Some spillage of the drum contents was visible on the asphalt surface. AEE recommends that soil samples be collected from the stained area to determine whether subsurface contamination has occurred in this area.

PHOTO 4: View of truck maintenance shop building showing chemical storage container (foreground), solvent-containing drum near the blue entrance door, and approximate location of waste oil UST.

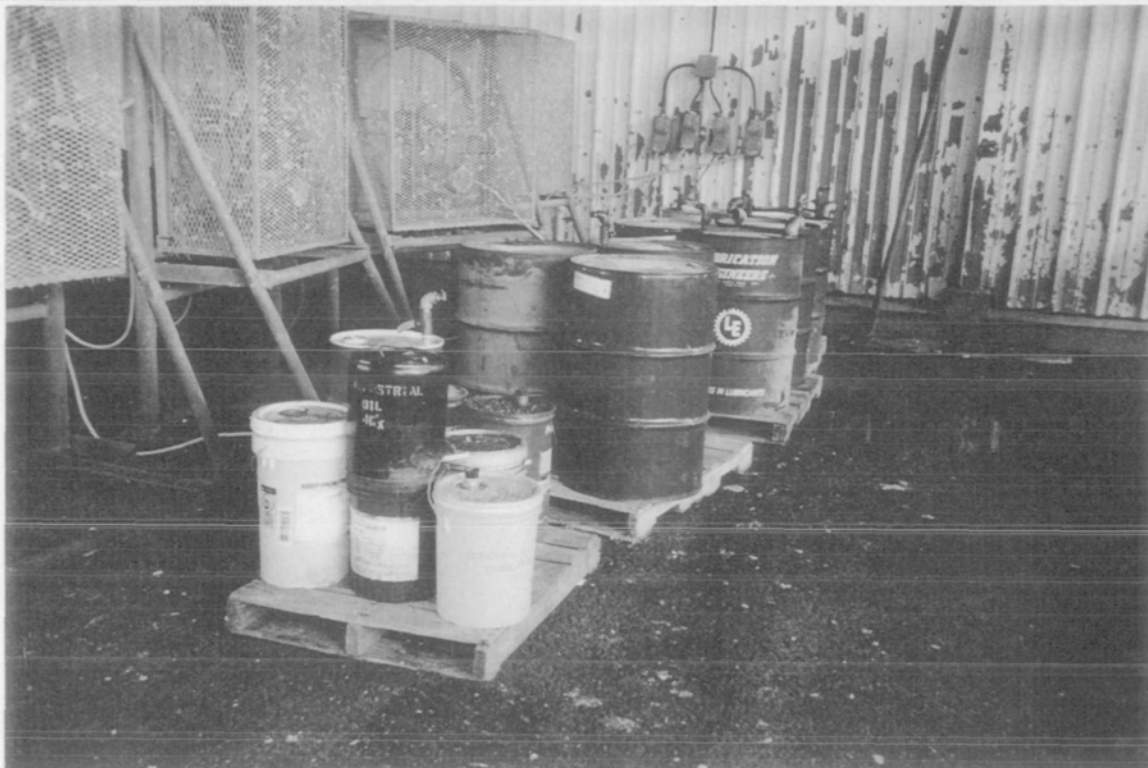
PHOTO 5: Photograph depicting chemical storage containers observed on pallets in the vicinity of the live chicken storage area. Note yellow drum of electrical insulating oil (potentially PCB-containing).

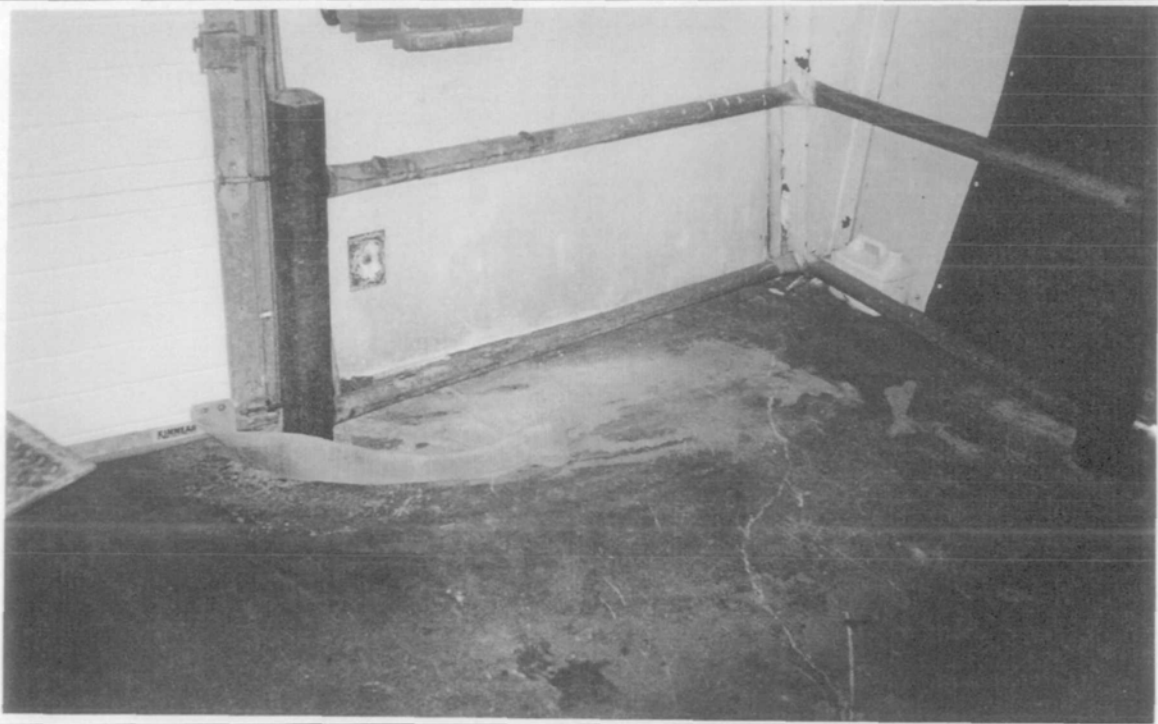
PHOTO 6: Photograph showing former location of the forklift battery recharging station. Note visible staining of concrete slab in this area and corrosion of metal surfaces indicating possible spillage of battery acid.

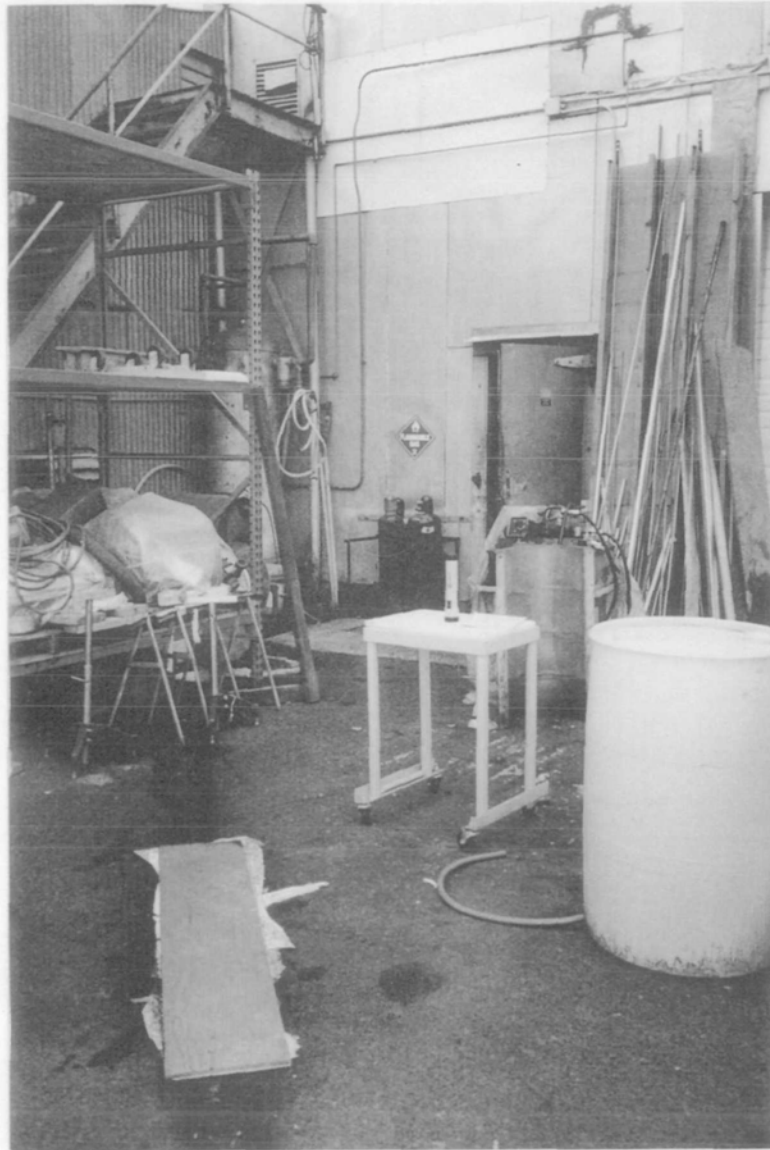
PHOTO 7:

An oil/water separator was present outside of the engine room, on the west side of the building. Numerous absorbent pads were observed on the asphalt in the area surrounding the O/W separator. Heavy oil staining was visible on the asphalt floor beneath the O/W separator drum and along a crack or groove in the asphalt that extends approximately 10 feet away from the O/W separator in the westerly direction (Photo 7). The O/W separator equipment consisted of a barrel with a simple on/off valve at the base of the barrel. Oil reportedly enters the barrel through a hose at the top and the water from the separator is drained from the valve onto the asphalt floor. Periodically, oil from the O/W separator barrel is disposed of into the waste oil UST at the truck maintenance shop. This requires the oil inlet hose to be temporarily disconnected from the O/W separator barrel. During this time, the hose is placed on a sorbent pad and the oil allowed to drain onto the pad until the separator has been emptied. Runoff from this area is confined to asphalt-paved areas until it reportedly reaches catch basin #4 (CB#4) which drains into the Willamette River. A storage rack of miscellaneous pipe and other items was located along the building wall to the northwest of the O/W separator. No chemicals were observed to be stored in this area.

Heavy soil staining was observed in the area of the oil/water separator and appeared to be concentrated on the asphalt immediately surrounding the separator and along a crack or groove in the asphalt that extends approximately 10 feet away from the separator. Because the PCB contamination could result in cleanup liability, AEE recommends that soil samples be collected from the stained area to evaluate the extent of PCB and TPH contamination. Prior work at the site has revealed PCB-contaminated soils in this area. If DEQ becomes aware of the PCB contamination, this could result in a listing of the site by DEQ and a requirement for cleanup. AEE is unaware of any reporting requirements at this time.

View of oil/water separator area showing location of oil staining along crack or groove in asphalt.
